# *A characterisation of the physical properties of soil and the implications for landslide occurrence on the slopes of Mount Elgon, Eastern Uganda*

## **Natural Hazards**

# A characterisation of the physical properties of soil and the implications for landslide occurrence on the slopes of Mount Elgon, Eastern Uganda

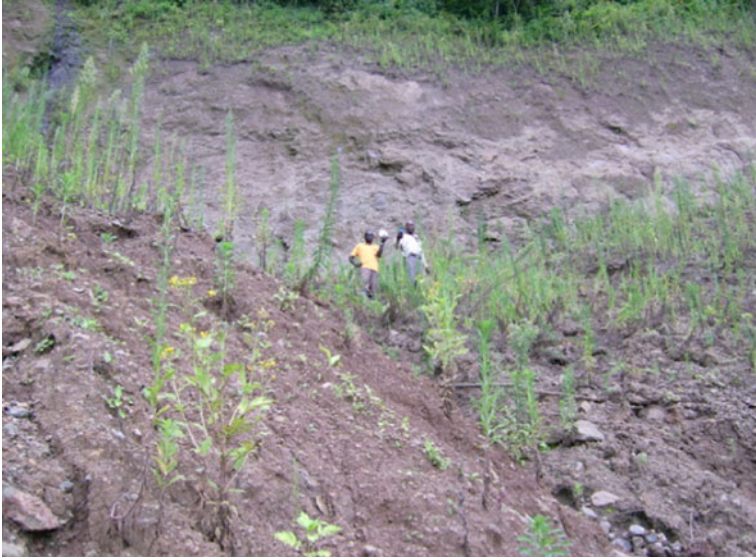
Buwabwala is situated in the Tsekululu Sub-County on the mid-slopes (1,900–2,500 m above sea level, slope angle 36°–58°) of Mount Elgon in Bubulo County, Manafwa District, Eastern Uganda. Despite being inside the Mount Elgon National Park boundary, this area has been heavily encroached for agriculture, grazing, the collection of firewood, harvesting of construction materials and the poaching of animals. A series of periodic deep and shallow debris flows were reported to have occurred in this area in the past. A deep debris slide which occurred in June 2006 (one of the wettest months in this area) after a spell of torrential rainfall events was surveyed and mapped in the present study (see Fig 2).

**Fig. 2** Part of the deep debris flow site at Buwabwala

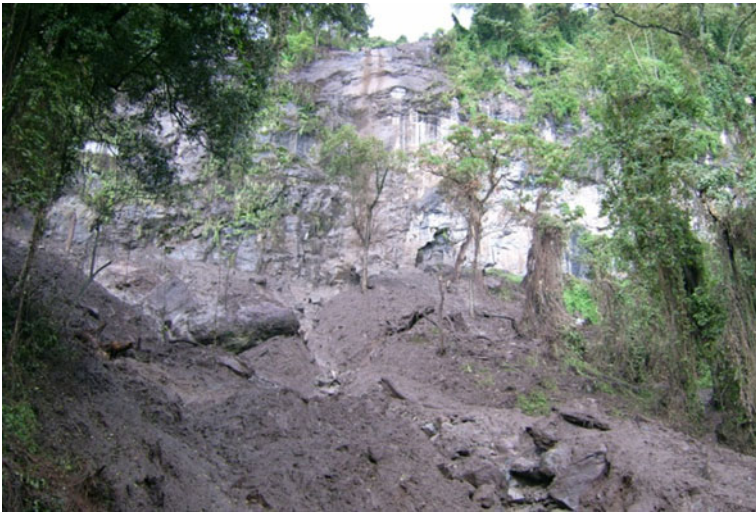
This is a deep mudflow that occurred during the intense rainfall spell experienced in December 2008 (see Fig. 3). The Kitati site is located in Bumulegi Village, Budadiri East County, Sironko District. It lies at an altitude range of 2,000 to 2,500 m above sea level; and it is part of the steep (33°–56°) pristine densely forested slopes of the gazetted National Park. Given that previous landslide investigations in the area (Breugelmans 2003; Knapen 2003; Kitutu et al. 2004; Knapen et al. 2006; Claessens et al. 2007; Kitutu et al. 2009) were conducted at sites impacted by human activity, this site presented the unique and intriguing scenario of having occurred in a pristine protected area, particularly as there was a need to gain an understanding of the underpinnings of landslide occurrence in an area that was devoid of any human impacts.

**Fig. 3** Part of the Kitati landslide site on the pristine densely forested slopes of Mt. Elgon National Park

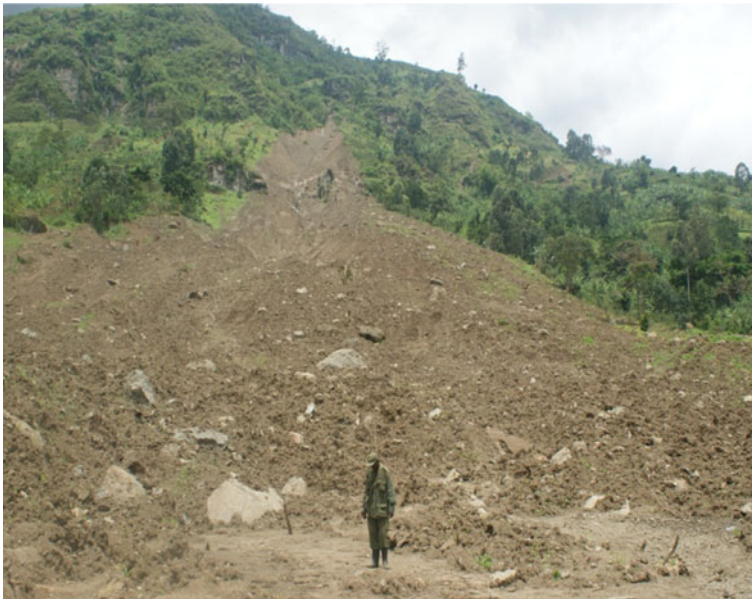
rugged, steep slopes ranging between  $36^\circ$  and  $56^\circ$ . Field observations revealed that this landslide was a deep debris flow at an altitude of 1,900 m above sea level. It occurred on 1 March 2010, after a series of torrential rains. It moved enormous volumes of soil mass and boulders (Fig. 4), burying three villages and killing over 300 people who had gathered on a market day.

**Fig. 4** Killer landslide at Nametsi Village. Over 300 people, homes and a community health centre were buried by the debris flow

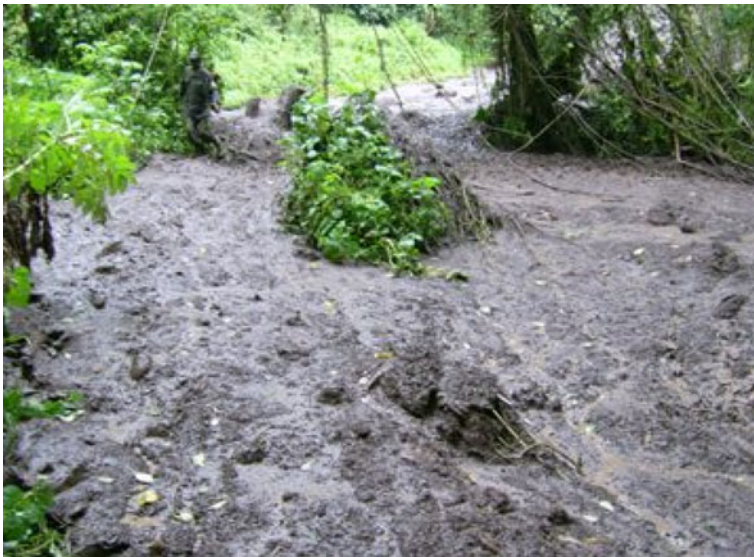
**Fig. 7** Mudflow at the Kitati landslide site
