**LANDSLIDE OCCURRENCES IN THE HILLY AREAS
OF BUDUDA DISTRICT IN EASTERN UGANDA AND
THEIR CAUSES**

**A THESIS SUBMITTED TO THE GRADUATE
SCHOOL FOR THE AWARD OF THE DEGREE OF
DOCTOR OF PHILOSOPHY
OF MAKERERE UNIVERSITY**

DECEMBER 2010

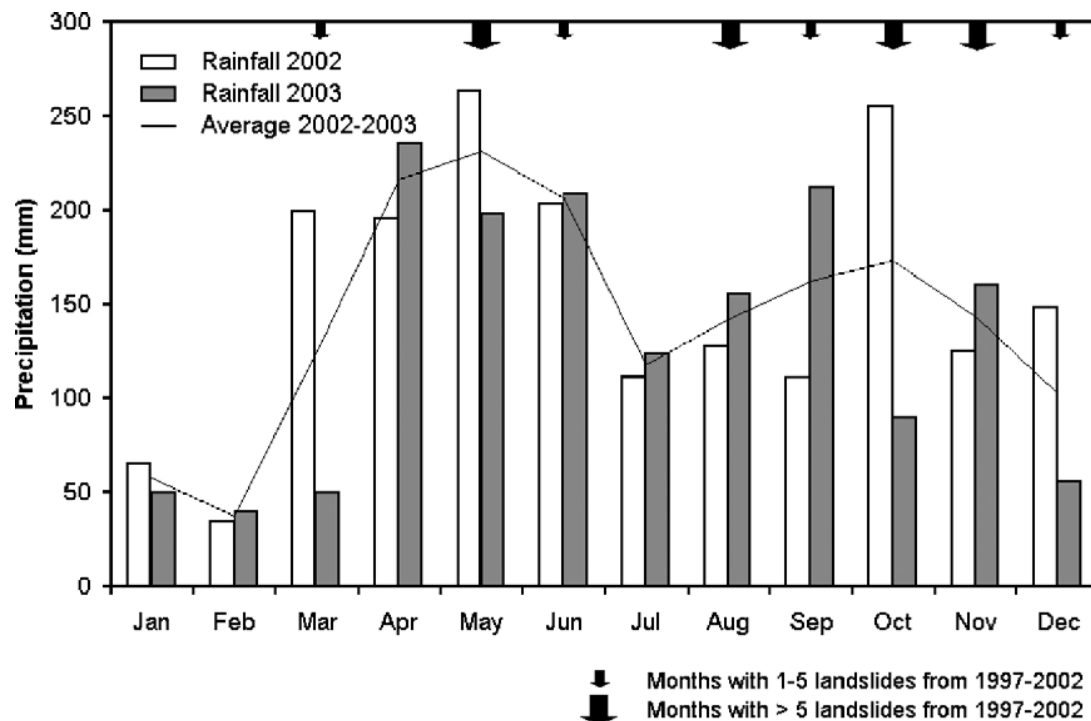
Figure 6: Monthly rainfall for 2002 - 2003 at Bulucheke (1350 a.s.l) measured using a local raingauge. Months with landslides information obtained from farmers. (Knapen *et.al*, 2006).

them were vandalized and only two at Bududa S.S and Bulucheke (Figure 6) were successful which shows the limitation of data collection in this area. The rainfall peaks for rainfall data collected by farmers compare with that from the Department of meteorology (Figures 5 and 6). Information from farmers reveals that rainfall showers mostly occur in the afternoon hours while the mornings are clearer with no rains apart from some seasons of higher rainfall when it rains throughout the day. No temperature extremes exist in this region due to its location near the equator and altitudinal variations. Average maximum temperature ranges from 27 to 32°C, the minimum temperature from 15 to 17°C. High cloud cover, relatively low temperatures, high rainfall and high relative humidity (76% in the morning and 57% during afternoon) contribute to low evapotranspiration (NEMA, 1997).

landslides (Inganga et al., 2001). During intermittent rainfall, soils lose their moisture and regain their strength within a few days. Saturation of the soils needs a much longer period, explaining the higher number of landslides in the Ethiopian highlands during September than in July. The higher precipitation amount during July is absorbed by the dry soil. Towards September these soils become saturated resulting in a higher possibility of slope failures (Ayalew, 1999). A distinct rainfall threshold for the initiation of landslides is difficult to assess for Bududa District because of the range of landslide types and dimensions, the heterogeneity of the study area and the lack of known landslide dates and rainfall data (Knapen *et. al*, 2006). Landslide events most frequently take place in years with exceptionally high rainfall, such as 1998, especially at the end of the rainy season when the soil saturation is maximized. Based on the few landslides for which the date of occurrence could be traced (Figure 6), it is difficult to demonstrate this (Knapen *et. al*, 2006).

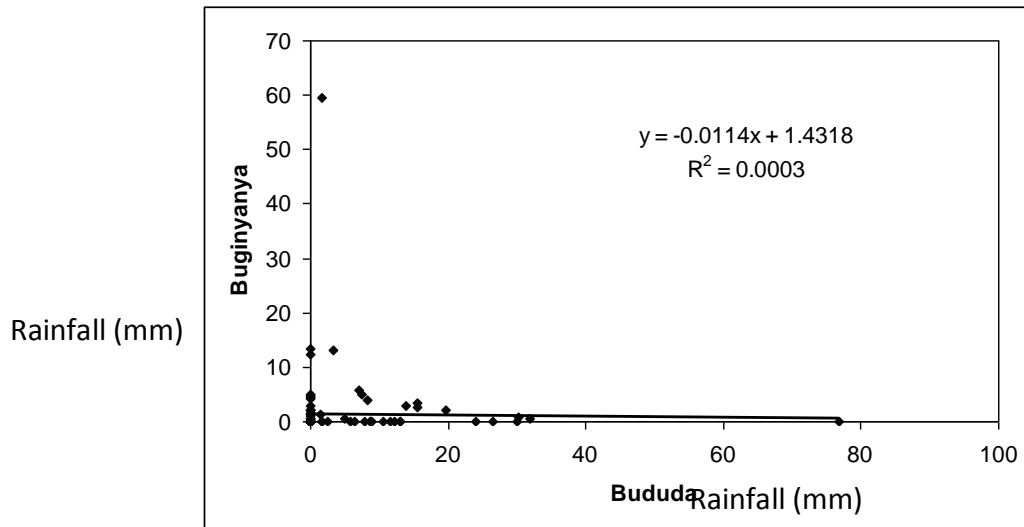
Figure 7: Correlation of rainfall data for Bududa with Buginyanya rainfall station

Rainfall data for the year 1997 for Bududa when many landslides occurred is not available. The daily rainfall data collected by farmers in 2002 and 2003 was correlated with that of Buginyanya and Mutufu rainfall stations for the same years. This was an attempt to determine whether there was relation in rainfall amounts between Bududa rainfall station and that of Buginyanya and Mutufu which would then allow estimation of rainfall amounts for Bududa for the period 1997 using statistical methods. The low values of R^2 in Figures 8 and 9 is an indication that there is no correlation in rainfall of Mutufu and Buginyanya with Bududa. However, there could be limitations in a way that rainfall for two years may not be sufficient to give a good statistical relationship. Otherwise the results suggest that rainfall in the Mount Elgon region is irregularly distributed. Currently the Meteorology Department gives data for the Mutufu station to represent the Mount Elgon area which may be misleading.

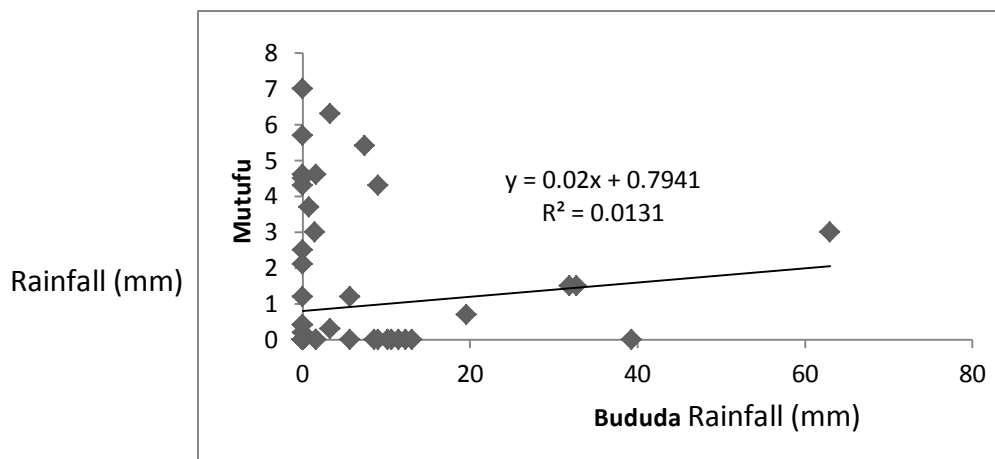
Figure 8: Correlation of rainfall data collected for Bududa with Mutufu rainfall station

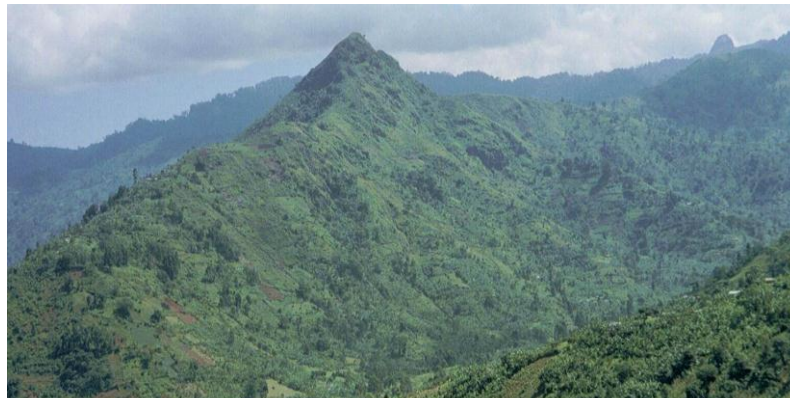
Figure 12: Nusu ridge dyke

The Nusu ridge (Figure 13) is very steep and has frequent landslide occurrences. The rock material is very soft and fractured as seen in Figure 14. The rocks are fractured and jointed. This makes the plants and shrub roots grow into the joints widening them allowing in more water infiltration and later the rock fails, given the steepness of the slope.

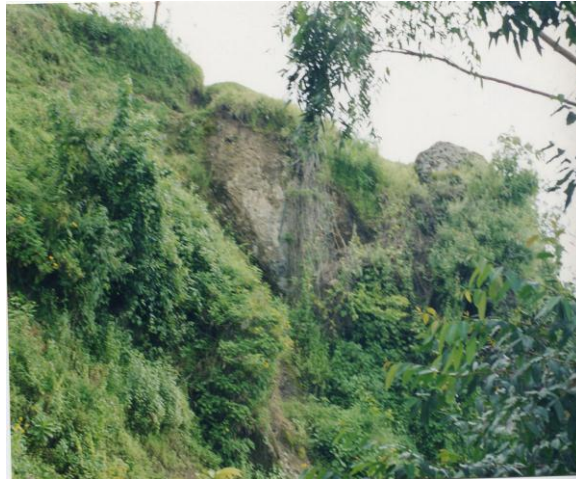
Figure 13: Fractured rocks at the tip of Nusu dyke

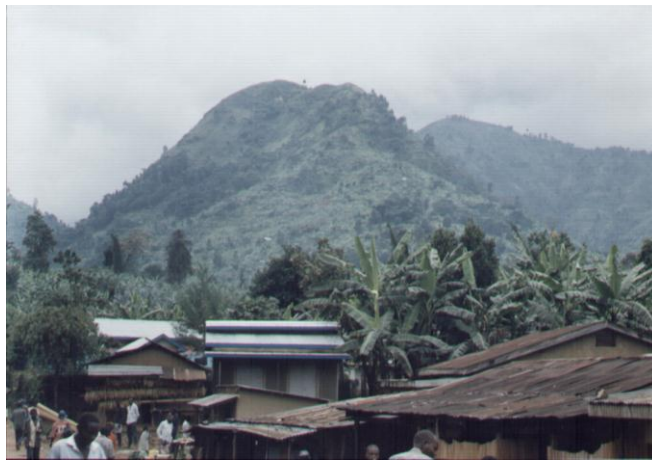
Figure 14: Kitsawa ridge dyke

The Kitsawa hill (Figure 15) is very steep and farmers indicate that they hear vibrations like the ground is hollow when they walk at the top of this hill. The soils are like dark ash and soft. No water or streams exist on this hill indicating that water does not infiltrate or if it does then there are no openings for it to come out. The Kitsawa ridge has stabilized landforms with evidence of past landslide activity. The types of landslides are the surfical which appear to be caused by water saturation between the soils and rock

discontinuity with the undercutting of the slope by a road constructed across the hill in 1984 acting as the triggering factor.

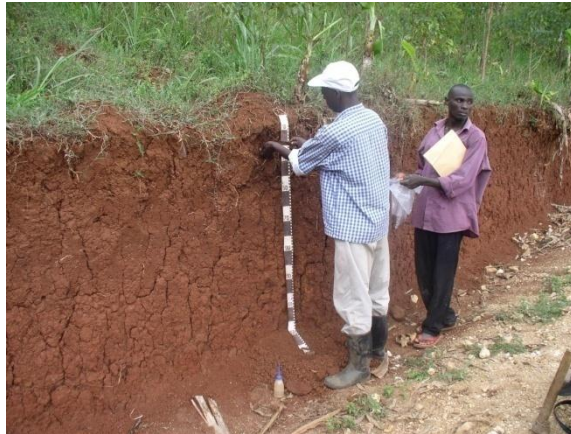
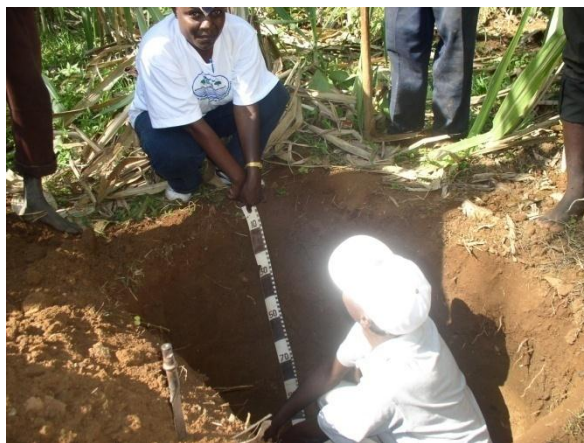
SOIL PROFILE EXAMINATION IN BUKIGAI AND BULUCHEKE SUBCOUNTIES

THE SITE FOR WATER INFILTRATION AT SAMPLE POINT GR12 NEAR THE NUSU RIDGE DYKE
